NATIONAL REGISTER OF HISTORIC PLACES
REGISTRATION FORM

historic name Stockton-Lindquist House

**STOCKTON-LINDQUIST HOUSE
DeLand, Volusia County, Florida**

The Stockton-Lindquist House, located at 244 East Beresford Avenue in DeLand, Florida, is a Frame Vernacular style residence built in 1878. Originally constructed as a small one-story dwelling, the house was substantially enlarged by the addition of one-and-a-half stories in 1895. Notable architectural features include an irregular floor plan, a balloon frame structural system on a brick pier foundation, with weatherboard exterior cladding. The front-gabled roof finished with stamped metal shingles has low cross gables extending outward the width of a pair of matched 1/1 light sash windows, and a brick chimney. Simple columns support the wrap around porch. Fenestration consists of original double-hung sash windows, some with leaded diamond patterns in the upper sashes. Through the retention of historic building materials and features, this former residence continues to convey its architectural significance.

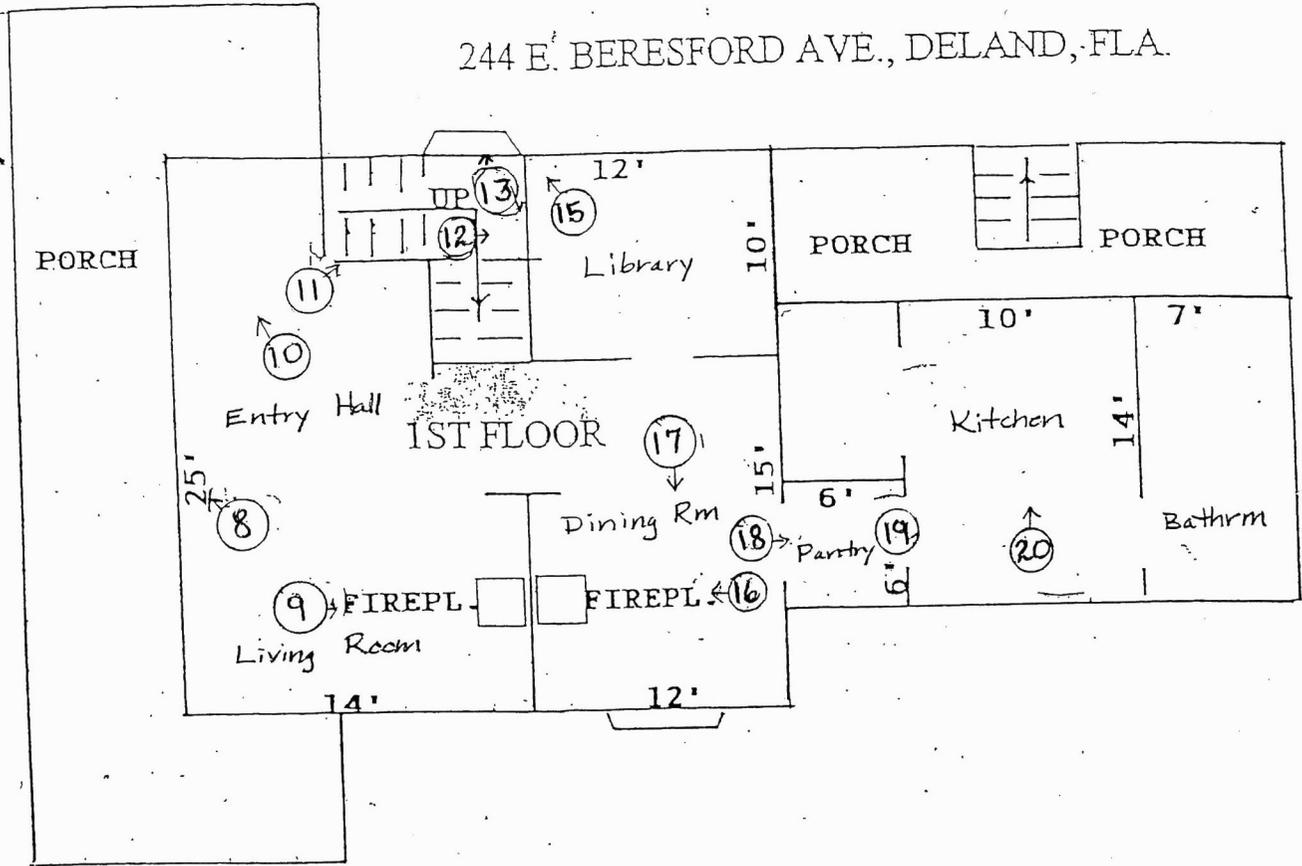
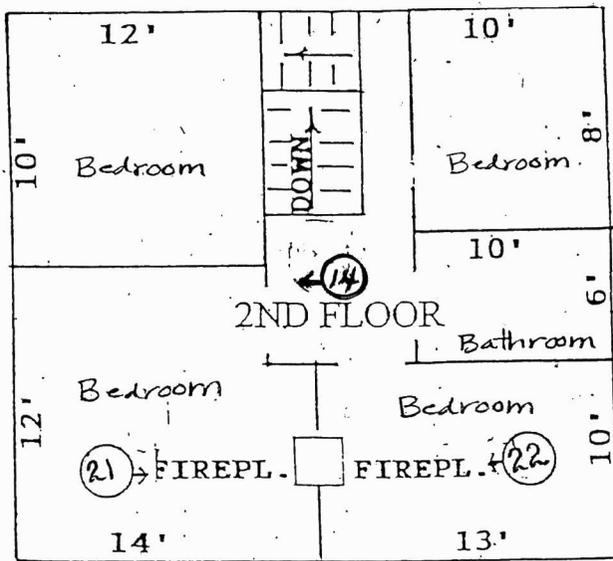
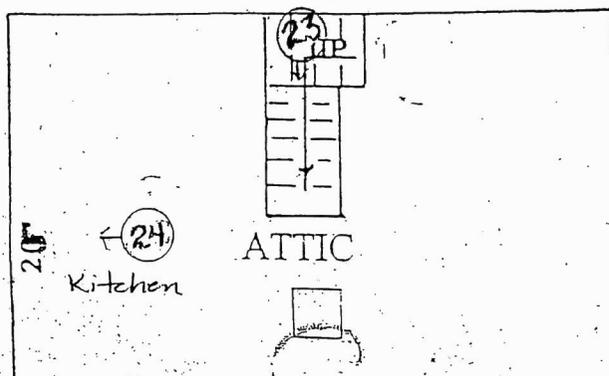
244 E. BERESFORD AVE., DELAND, FLA.

DIMENSIONS ARE ALL APPROXIMATE.
NOT TO SCALE.

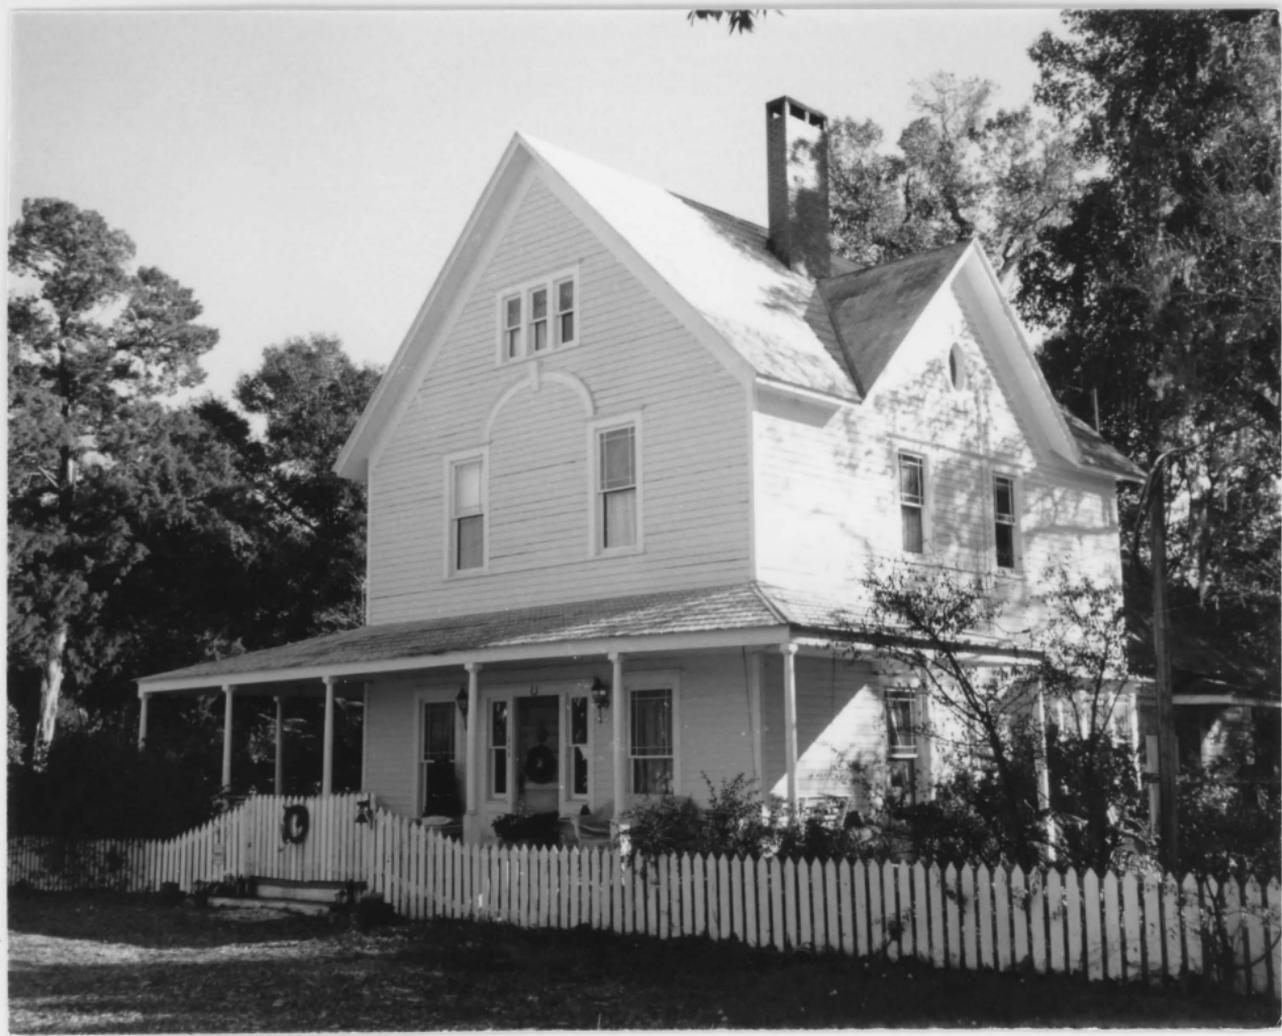
1. Stockton-Lindquist House
2. Volusia County, Florida
3. Kimberly Hinder and Tesa Norman
4. May, 2002
5. Archaeological Consultants, Inc.
6. Main (north) façade and west elevation, facing southeast
7. Photo #1 of 24

The two-and-a-half story Frame Vernacular Style residence has an irregular floor plan. The main (north) façade is symmetrical (Photos 1 & 2). The house is oriented to the north, facing East Beresford Avenue. A rectangular central block with a one-and-a-half story wing off of the rear elevation characterizes the form. Constructed of wood frame, the house is clad in wood drop siding, and built on brick piers.

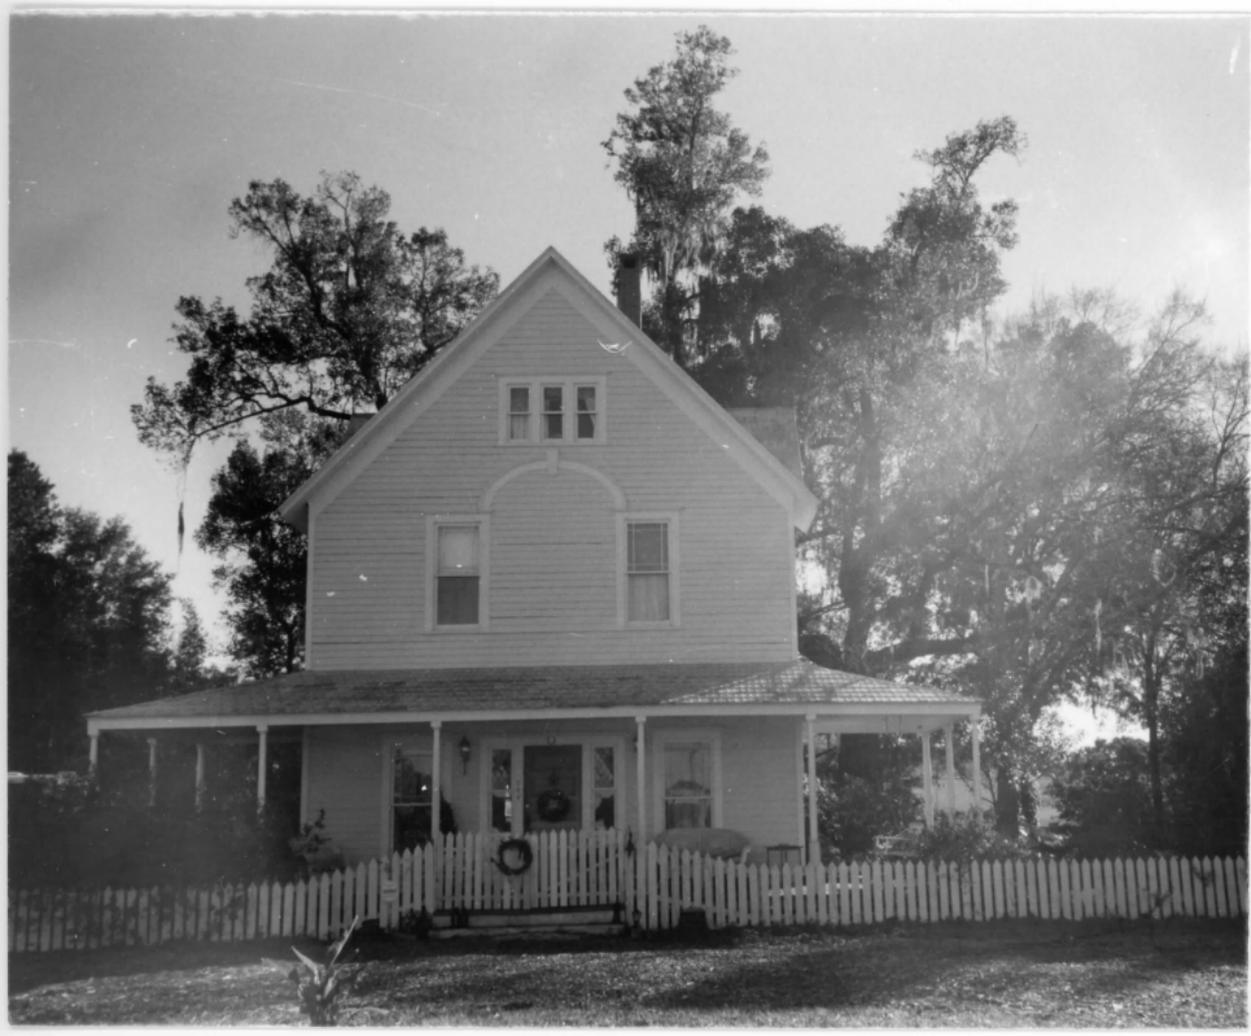
2

6. Exterior detail of main entrance, north façade, facing south
7. Photo #2 of 24

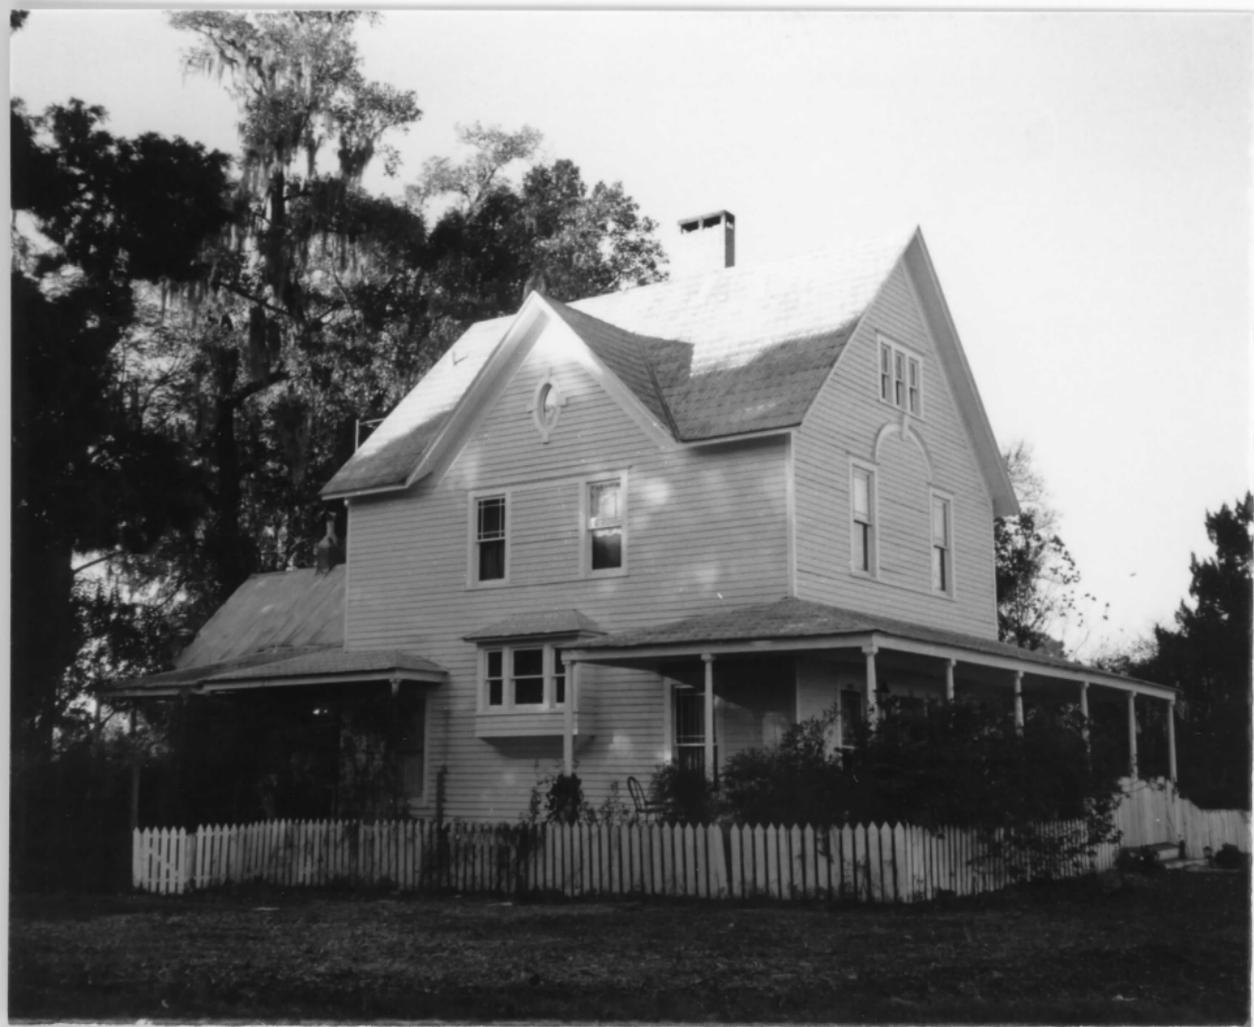
3

6. North and east elevations, facing southwest
7. Photo #3 of 24

A one-story wraparound porch extends across the north, east, and west elevations (Photo 3). Turned wood columns support the hip roof of the porch. A secondary porch is located at the south end of the east elevation that follows the same design as the main porch. The main entrance, centrally located on the north elevation, features the original five-panel wood door flanked by diamond pattern leaded glass sidelights.

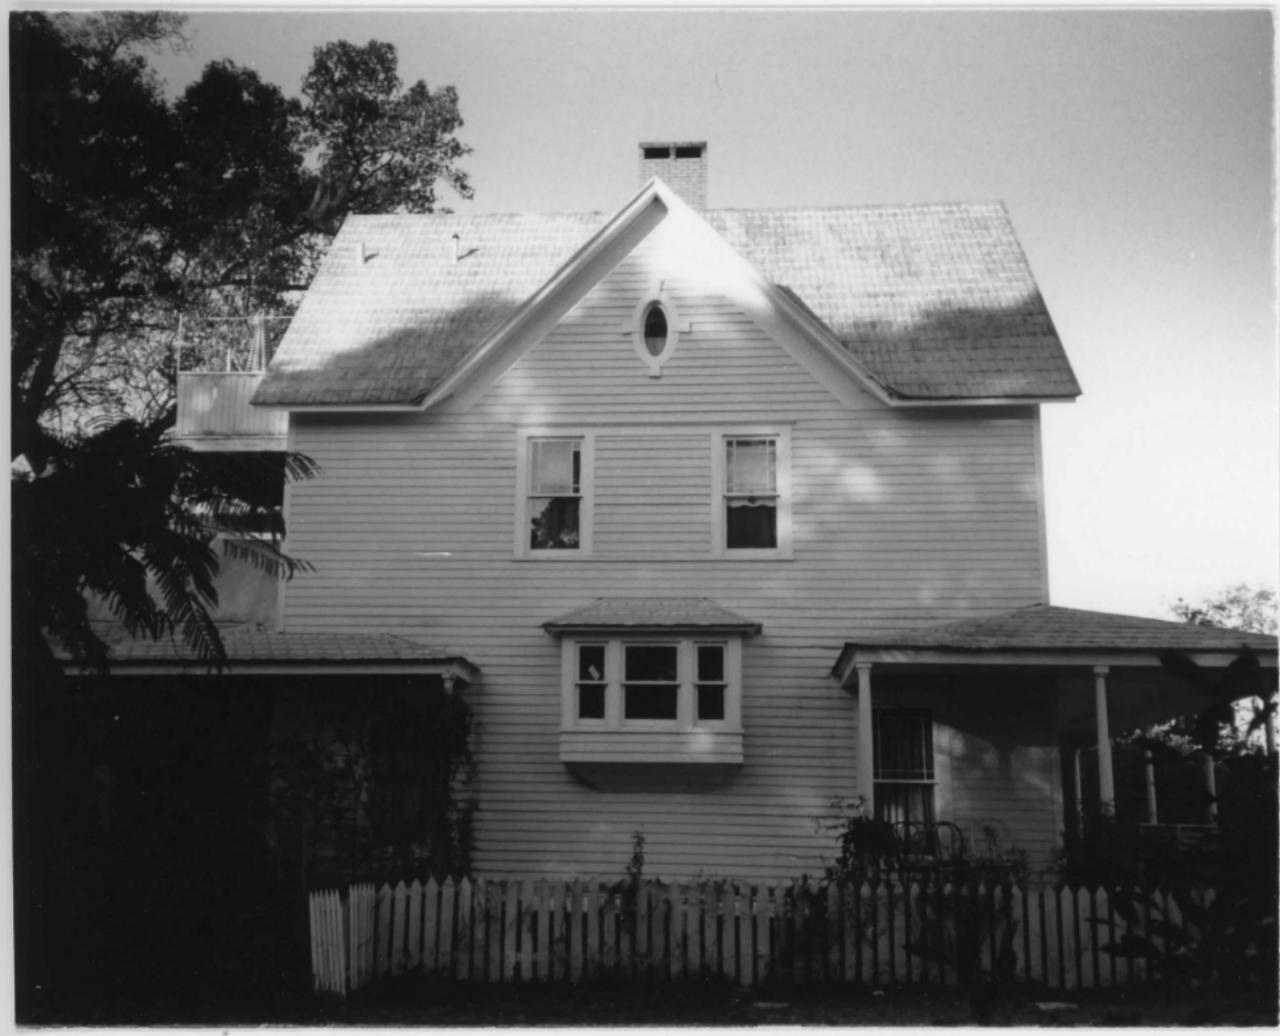
4

6. East elevation, facing west
7. Photo #4 of 24

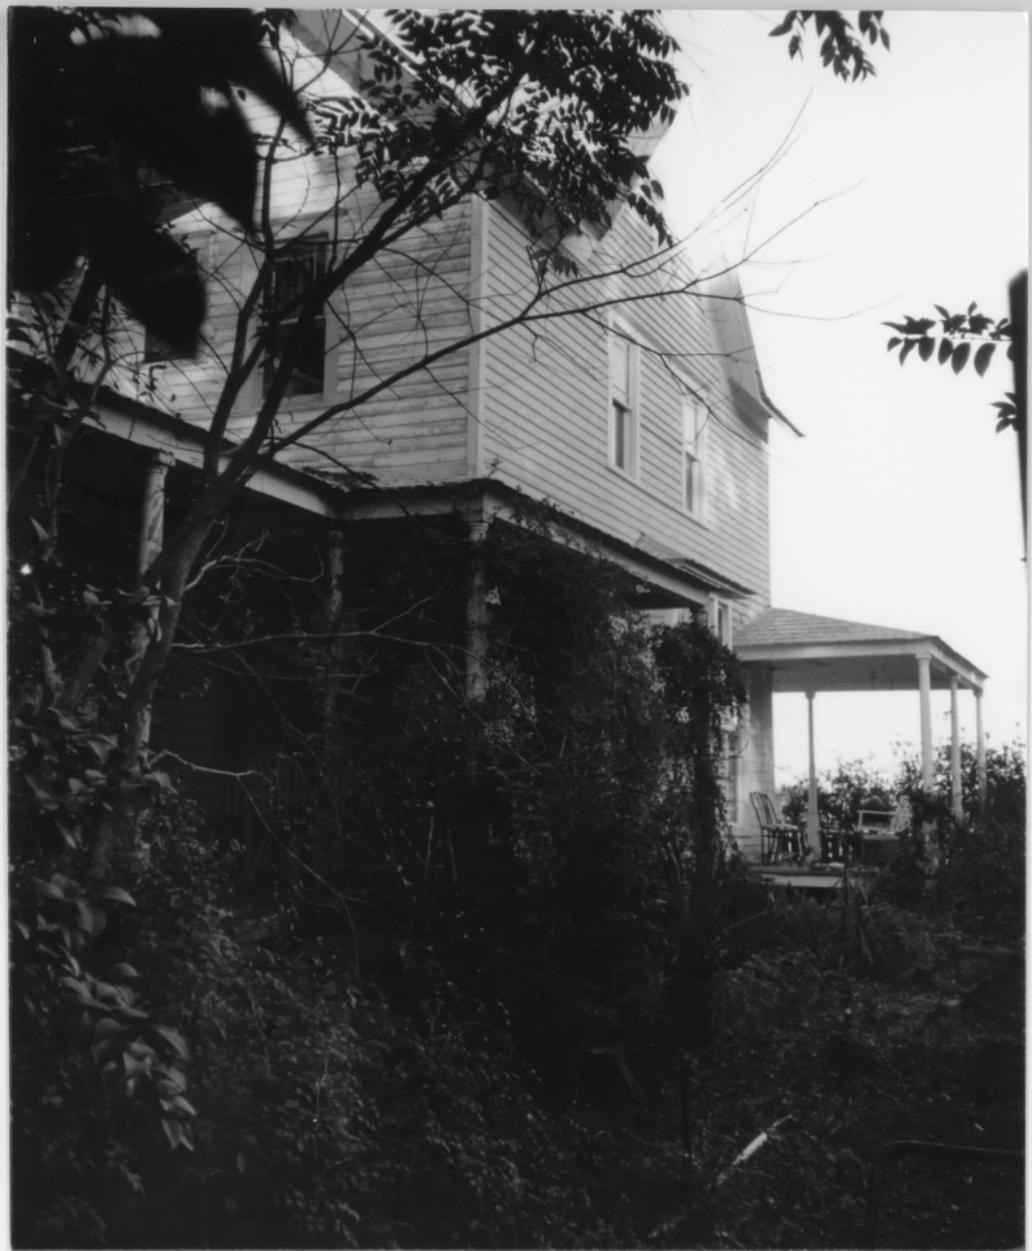
5

6. East elevation, facing northwest
7. Photo #5 of 24

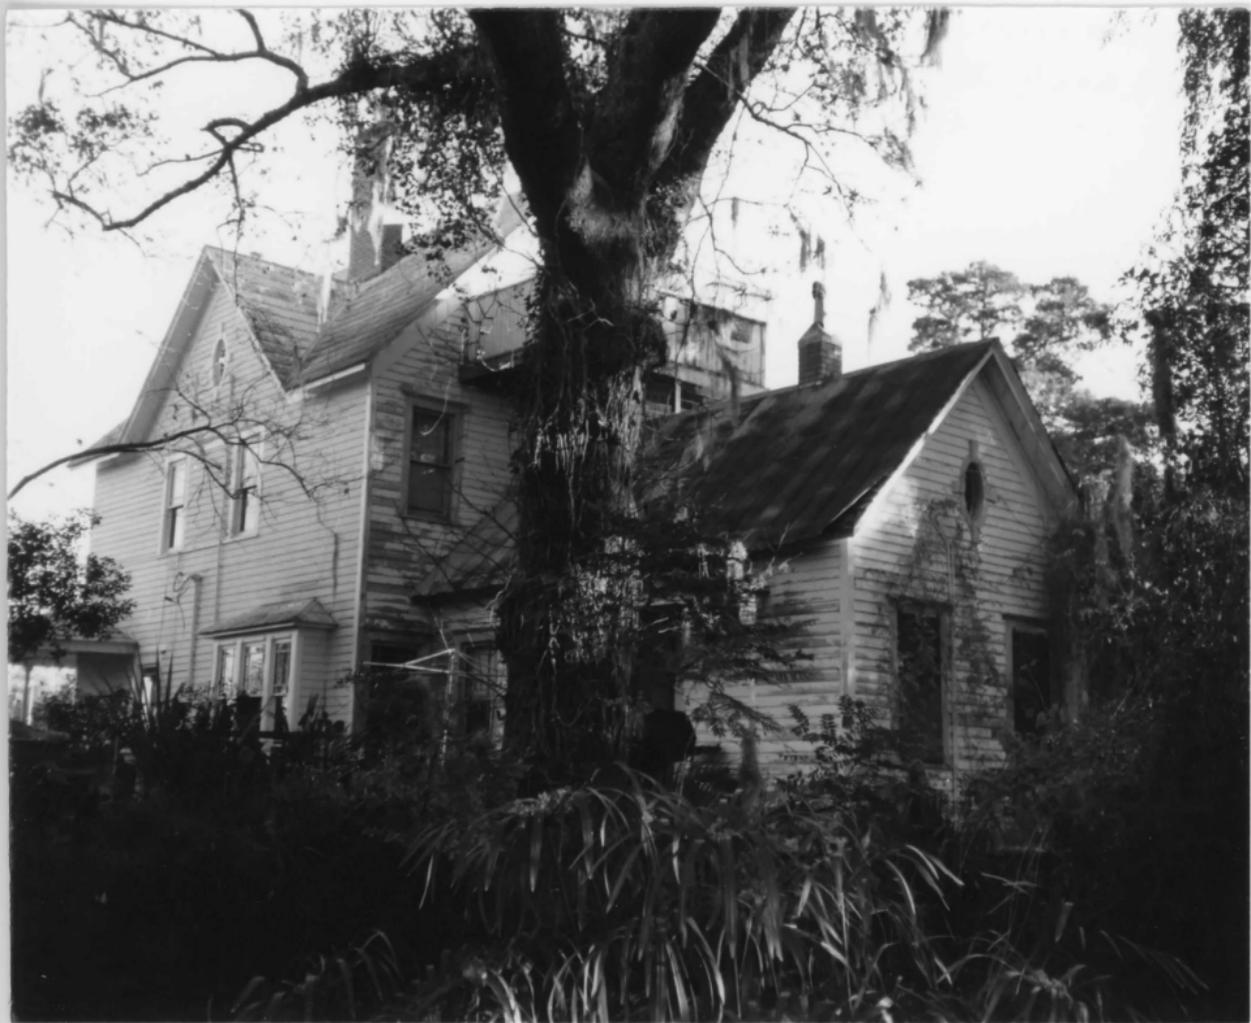
6

6. South and west elevations, facing northeast
7. Photo #6 of 24

The steeply pitched gable roof features small intersecting gables sheathed with stamped metal shingles. Two interior brick chimneys are present—one located at the ridgeline, the other in the west slope of the roof (Photo 6).

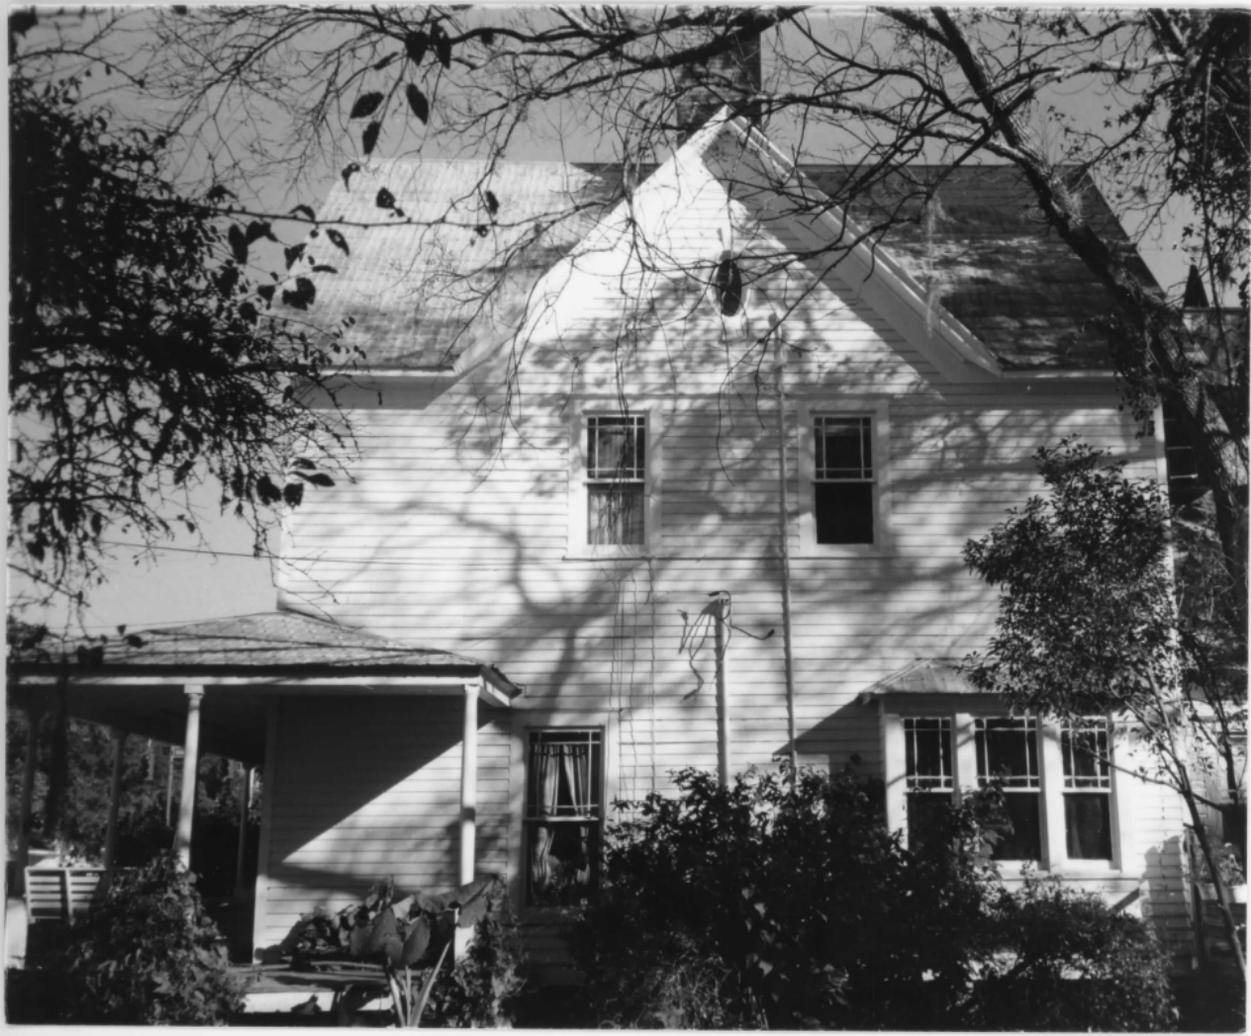
7

6. West elevation, facing east
7. Photo #7 of 24

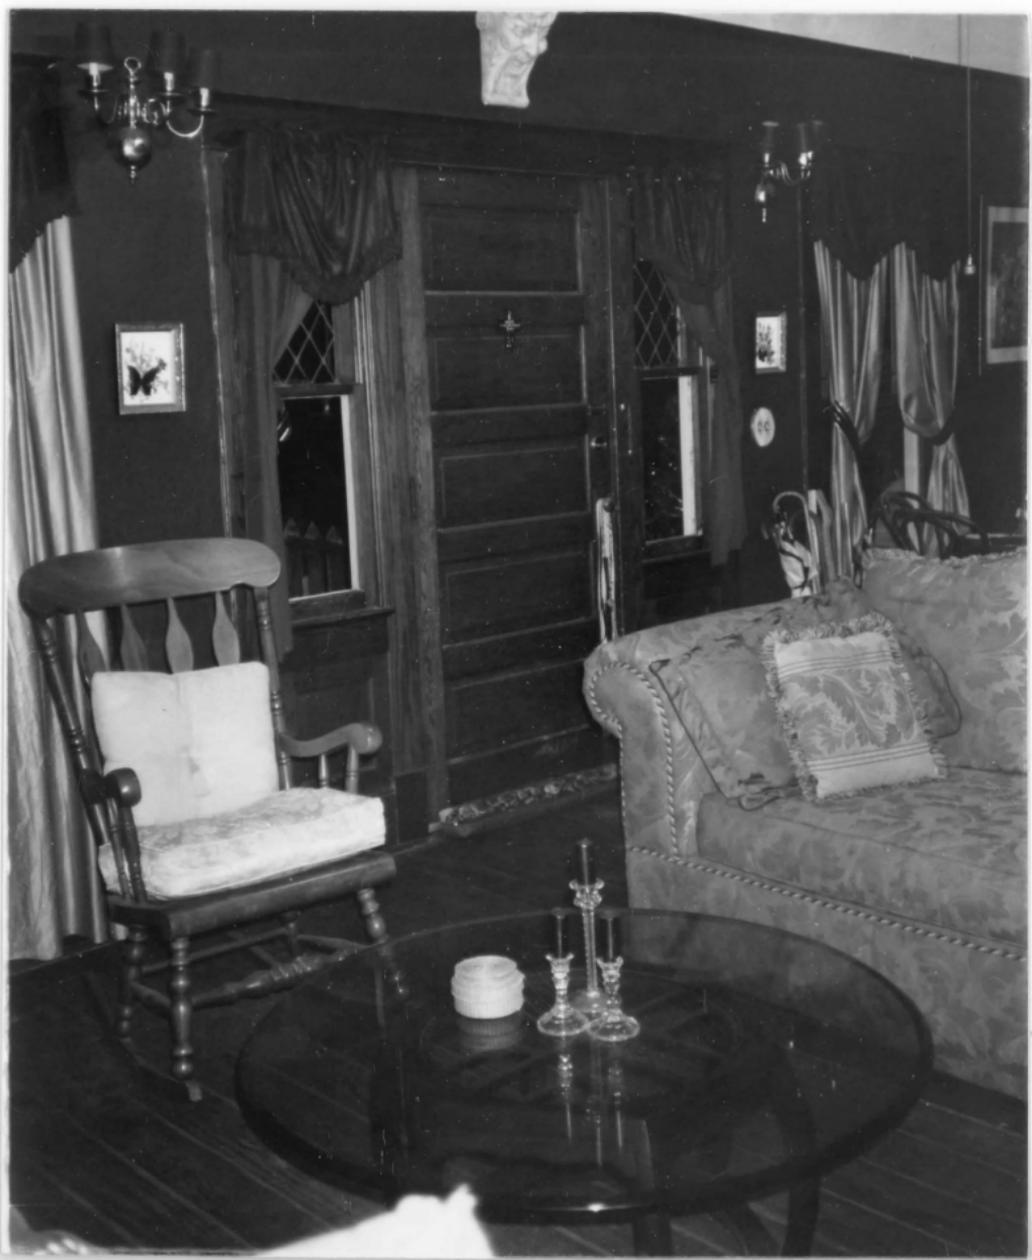
8

1. Stockton-Lindquist House
2. Volusia County, Florida
3. Terry Ann Thomas
4. January, 2004
5. Terry Ann Thomas
6. Interior detail of main entrance, facing northeast
7. Photo #8 of 24

The main entrance to the house is a central doorway with diamond-paned sidelights on the north elevation (Photo 8). The entry hall/living room features a brick fireplace (Photo 9) and a turned stairway to the second floor. The stairway has a stick balustrade and prominent newel posts, and a landing with benches (Photos 11-13). The first floor of the main block also includes a dining room and library. The one-story attachment includes a kitchen, bathroom, and porch. The second floor of the main block has four corner bedrooms and a bathroom. The attic has a living area, including a kitchenette, and provides access to a balcony located on the rear elevation (Photo 24).

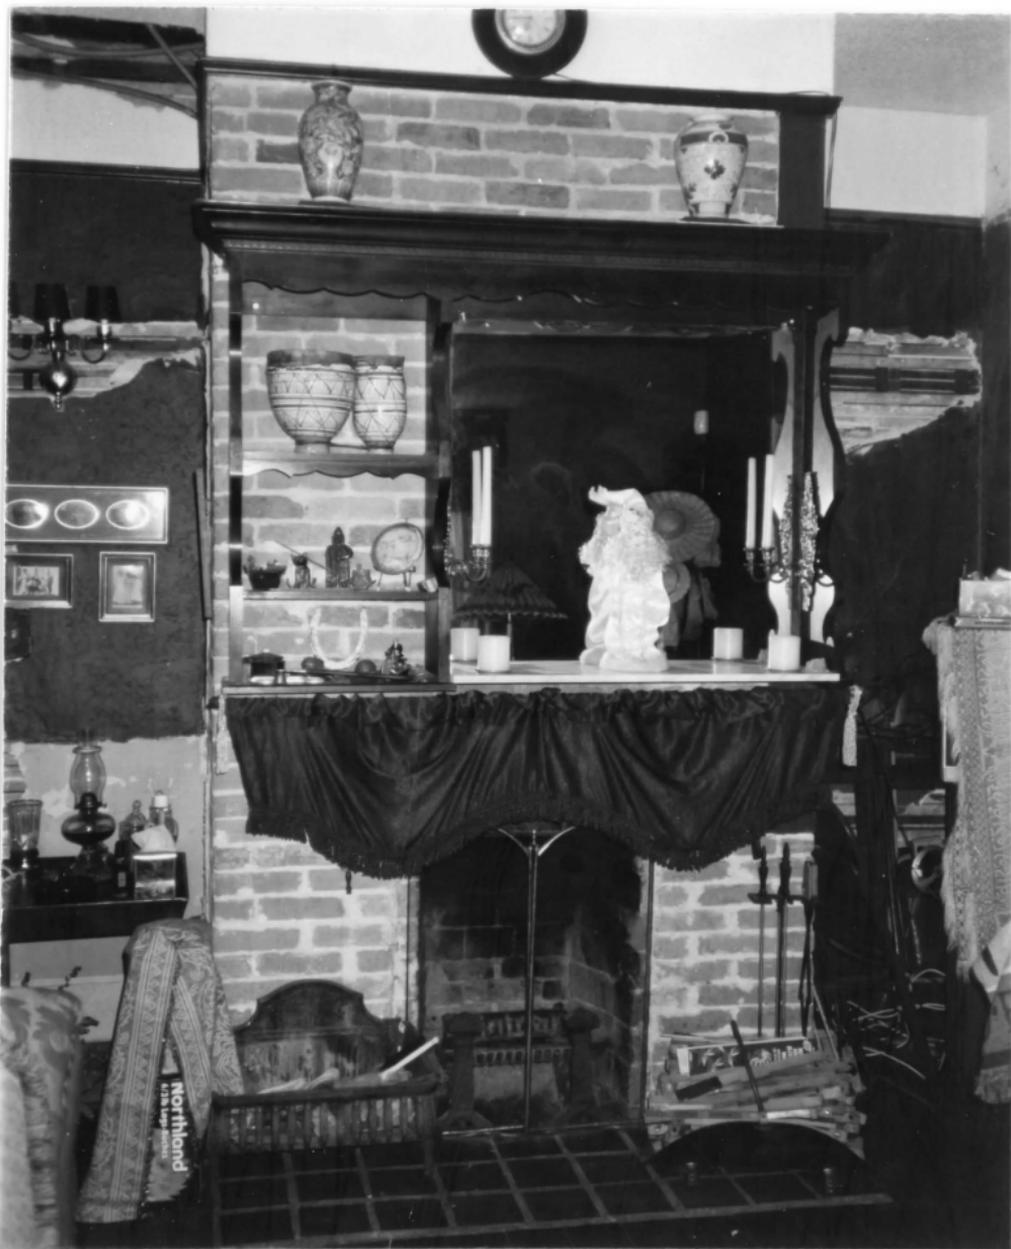
9

- 6. Detail of living room fireplace, facing south
- 7. Photo #9 of 24
